Event Highlights

Technical Summary

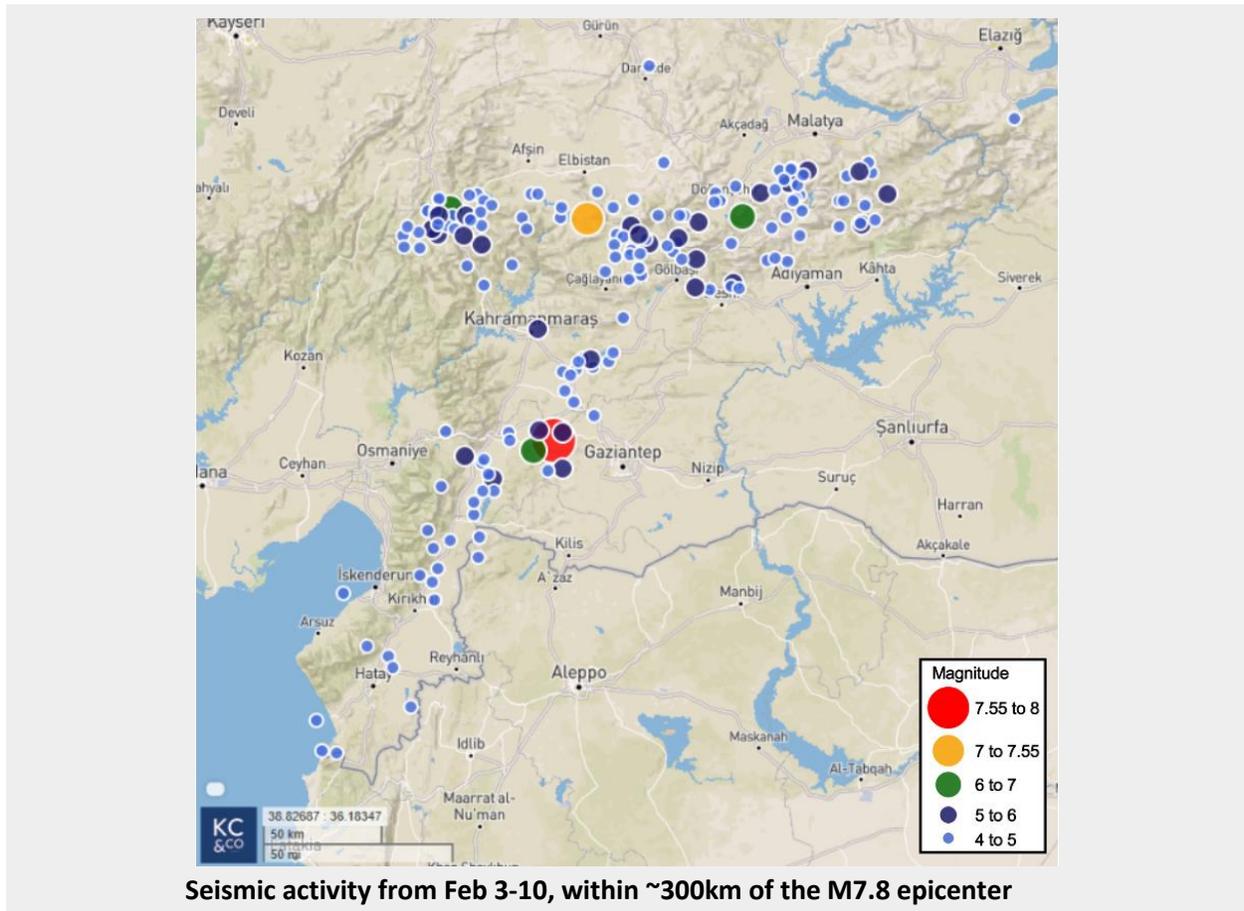
The February 6th M7.8 earthquake occurred near a triple junction of three tectonic plates in southeastern Turkey near the Turkey-Syria border, approximately 21 miles west of Gaziantep. It was followed by numerous aftershocks, the largest of which was a M7.5. **The mainshock is the largest magnitude event to occur in Turkey since the 1939 Erzincan M7.8 earthquake**, though a large-magnitude earthquake (M7.6) did strike the region near Izmit in 1999.

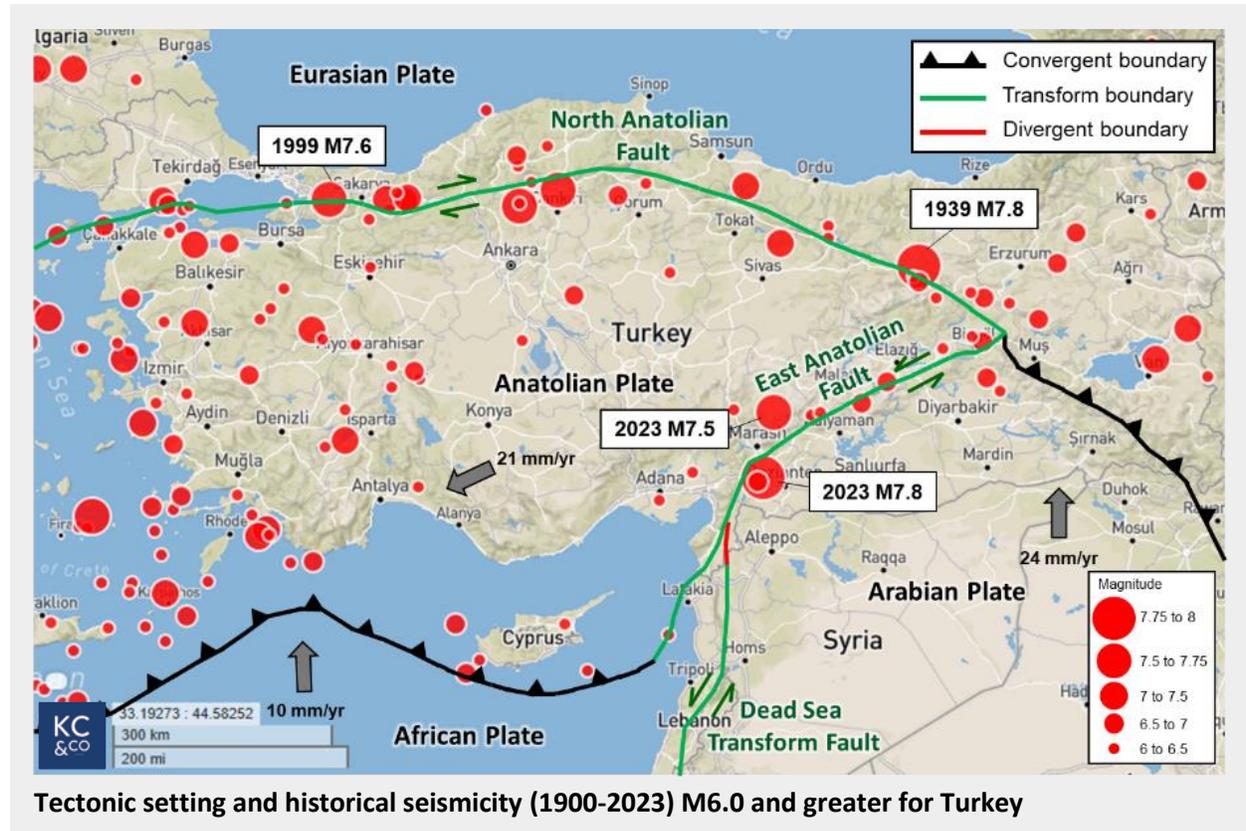
The US Geological Survey (USGS) has attributed the mainshock event to *strike-slip faulting* at shallow depth on a steeply dipping fault, likely within the East Anatolian fault zone. Strike-slip faulting occurs when the (crustal) blocks on either side of the fault line slide past each other horizontally. Another well-known example of a plate boundary strike-slip fault is the San Andreas Fault.

In southeastern Turkey, the African, Arabian, and Anatolian plates meet along a series of primarily transform plate boundaries. In a process known as *tectonic accommodation*, plates adjust and deform in response to stress and strain. In this case, translational motion between the Anatolian and Arabian plates is accommodated along the East Anatolian fault zone, with the Anatolian plate moving southwest. In northern Turkey, the southwest motion of the Anatolian plate is accommodated along the North Anatolian fault zone, which delineates the transform boundary between the Anatolian and Eurasian plates. Earthquakes are common near these strike-slip fault systems, with more than 50 earthquakes of M6 or larger since 1900, including 12 earthquakes that were M7 or larger.
